MEET THE CONDITIONS

Anti-corrosion coating failures are a significant factor in the reduced operational life of pipelines, says Dinko Cudic, Business Line Director, Seal For Life Industries, the Netherlands.

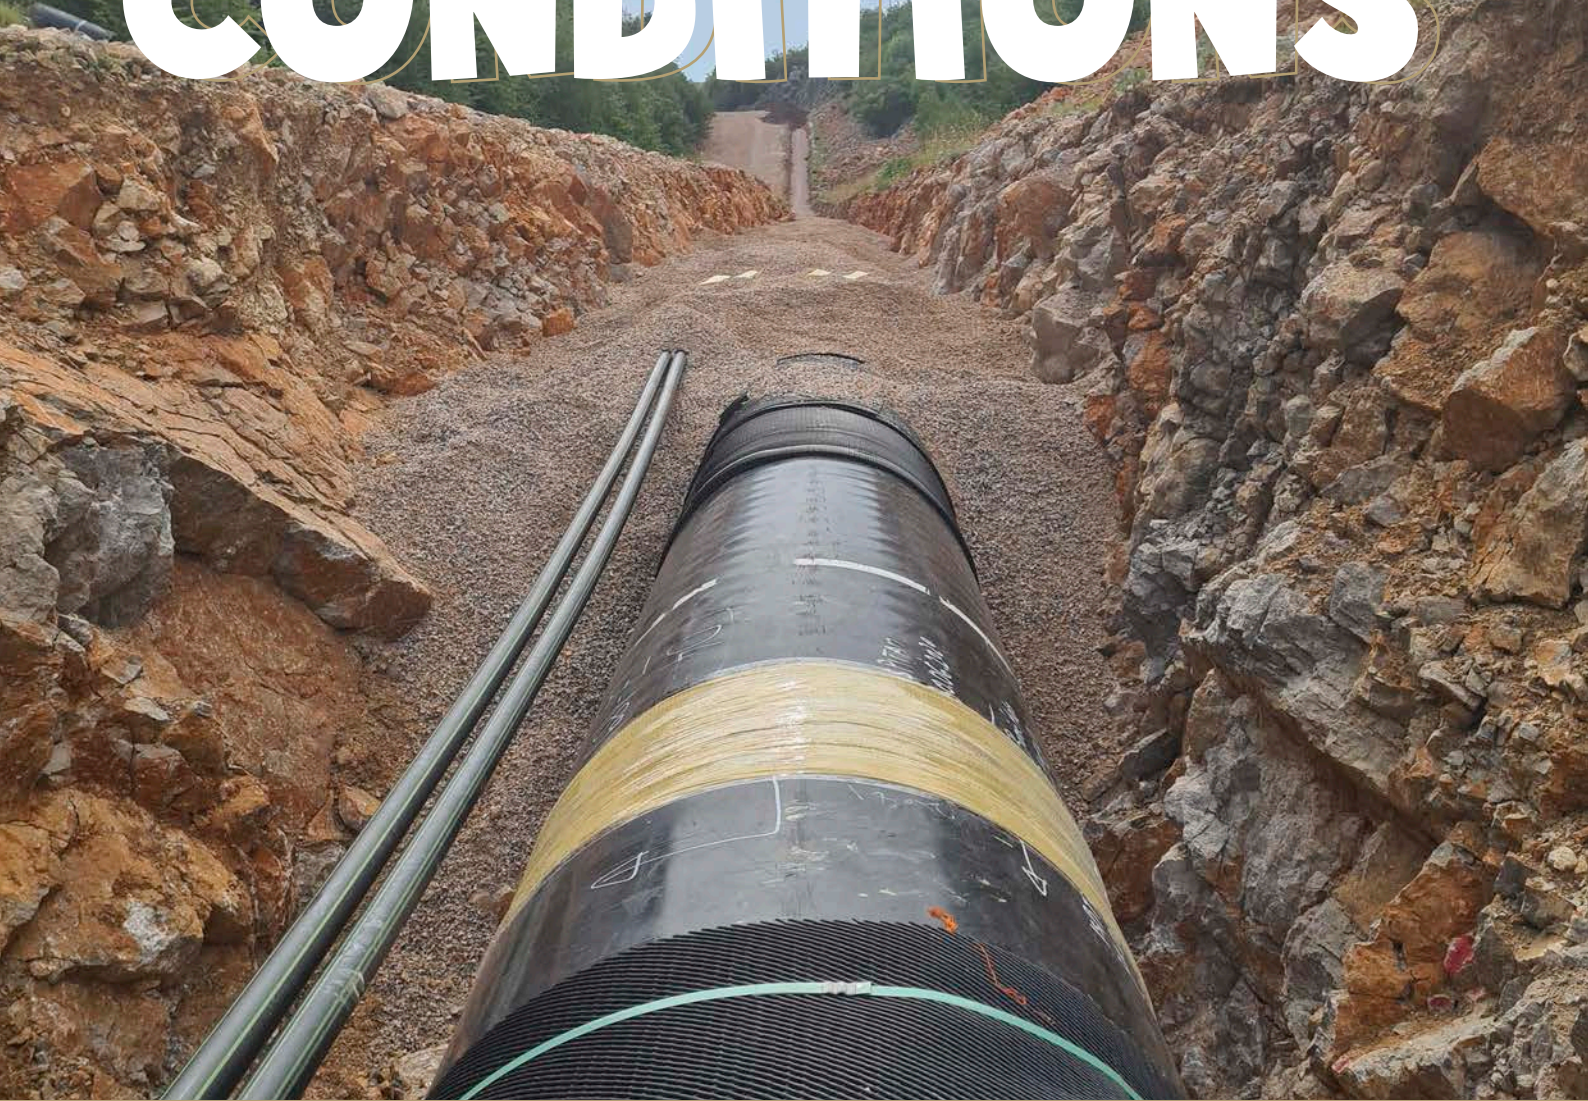
Figure 1. Pipework remains protected in case of mechanical damage or environmental conditions.

When the adhesive strength of a material is in the same range or higher than the cohesive strength, whenever you try to remove the coating in a wrap form, a certain portion of the coating material will always fully remain as a film on the surface of the metal pipe substrate, further protecting the pipe in case of mechanical damage or external forces like soil stress.

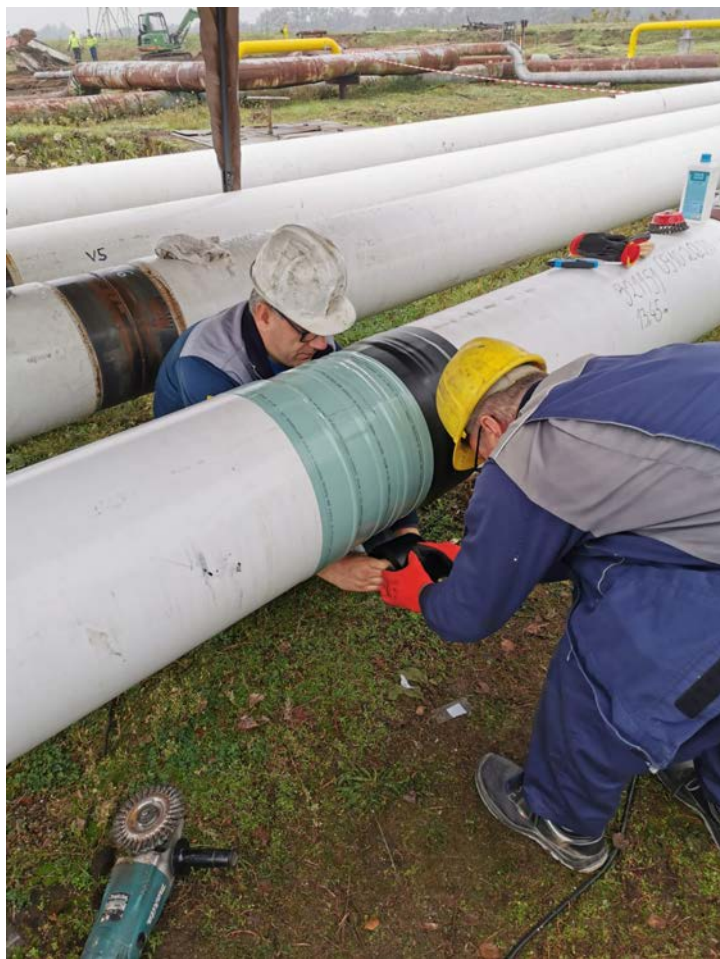
Figure 2. Simple and easy to install solution providing long-term corrosion protection.
